BELLS LAKE DAM

NJ 00405

**PHASE 1 INSPECTION REPORT
NATIONAL DAM SAFETY PROGRAM**

BELLS LAKE DAM (NJ00405)

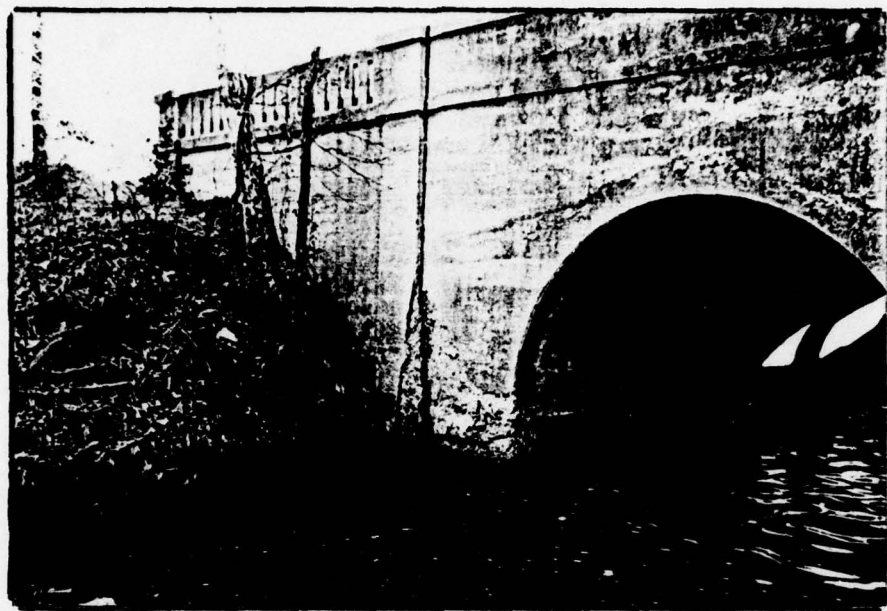
Downstream bridge opening

(2) Place additional riprap stone at the downstream pool immediately below the culvert outlet to prevent scour.

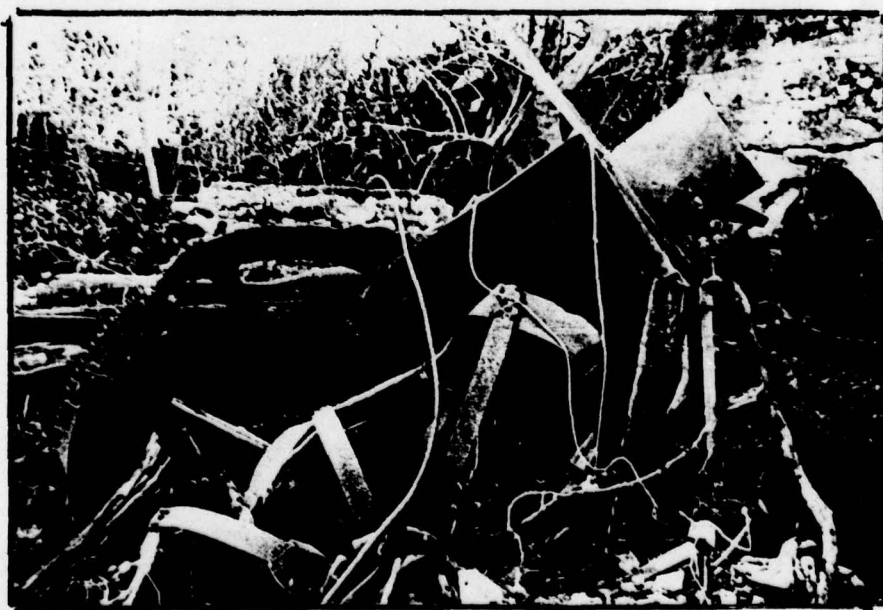
The iron millrace sluice gate at the right abutment is extremely old and demolished beyond repair. However, the gate could be employed in an emergency situation, if repaired. Immediately downstream in the raceway there is considerable steel and construction debris from the old mill equipment and building foundations.

Remains of old mill

(3) Remove the auxiliary sluiceway at the right abutment together with the grist mill debris. Safeload the existing culvert and build new embankment in the approach area and downstream power canal.

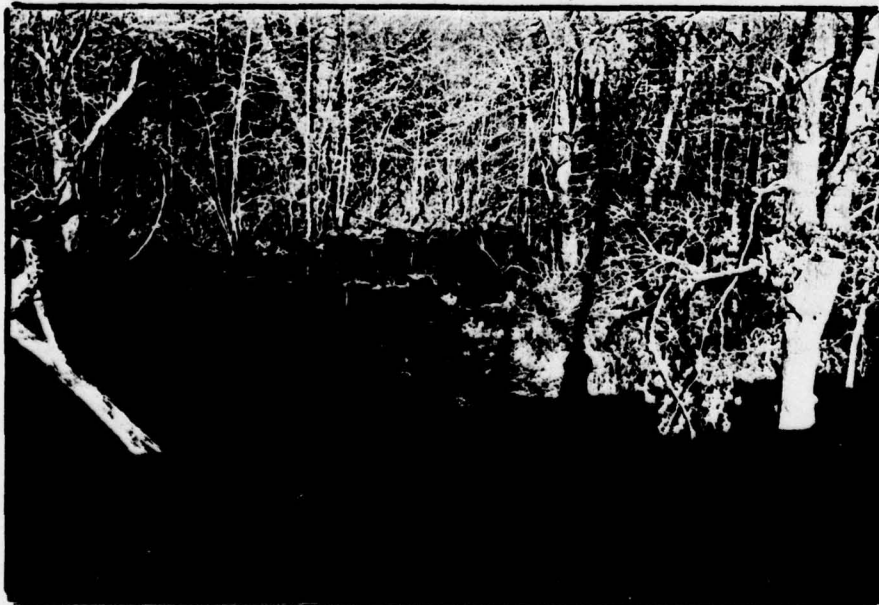
Downstream channel

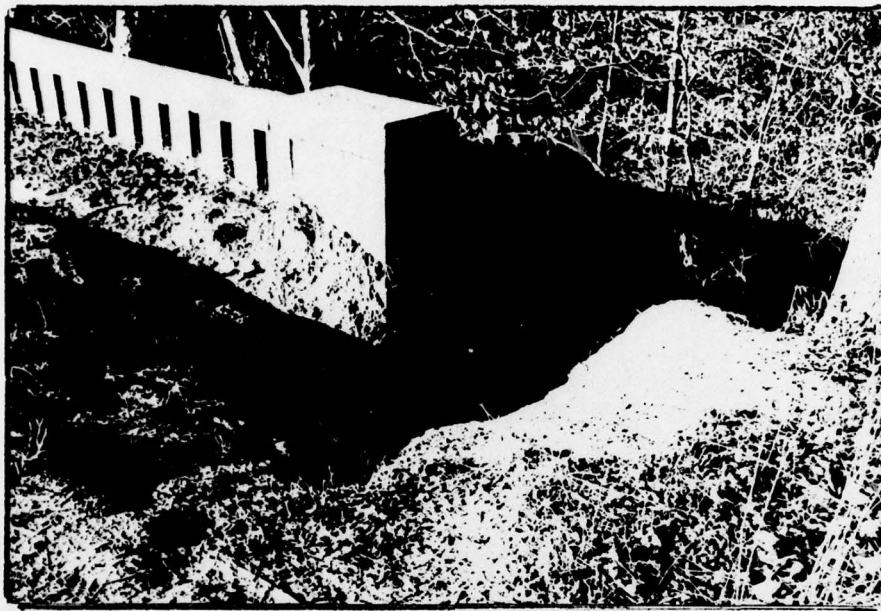
Erosion at NE wingwall

(7) The backslope areas at the ends of the bridge wingwalls should be regraded and protected with slope paving.

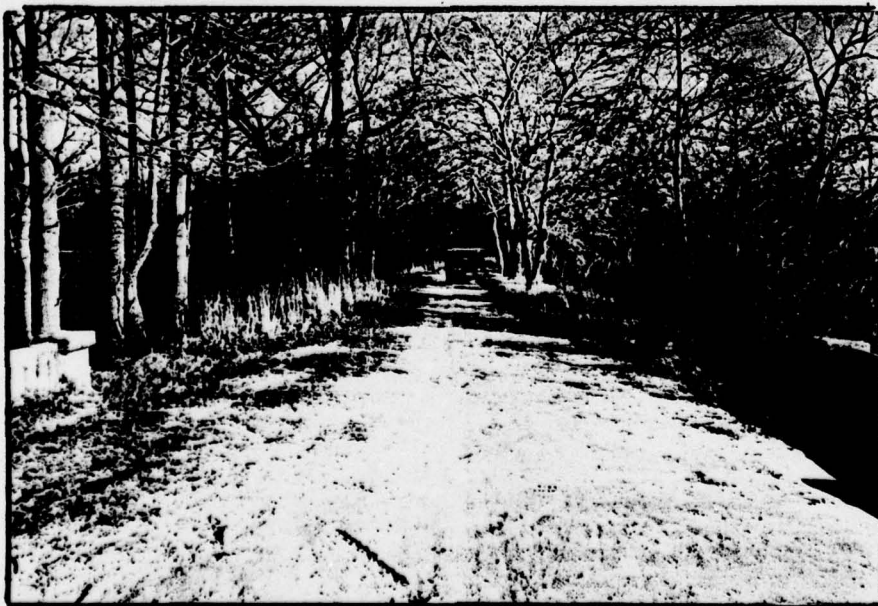
The embankment portions of the dam were found to be in moderately poor condition reflecting the age and apparent lack of maintenance on the backslopes. The lake water level appears to be quite constant during most periods as the banks are well stabilized and show little evidence of sloughing at the waterline. The dam sideslopes are partially protected with natural ground cover and have many large trees growing along the sides. There is ample evidence of considerable surface run-off and erosion in numerous locations below the dam crest which have cut out rather deep erosion channels, especially at the corners of the bridge wingwalls. The flatter upstream embankment slopes are very irregular and it appears the lake has silted up considerably against the upstream face. The bulkhead constructed along the upstream face, although rebuilt in 1940, is in an extremely poor condition where it is exposed. Major portions are completely demolished. The embankment backslopes shows evidence of numerous wet areas at the lower elevations, especially at the right abutment (in the vicinity of the old grist mill raceway). As can be seen in the appended photographs, there are numerous large (24-30") trees on the slopes and the possibility of piping around the root systems is of major concern. The top of the dam is quite rough and is composed of granular material in a loose condition. It requires additional clay binder and compaction to stabilize the surface which now is very irregular as a result of vehicular traffic which trespass onto the property.

View East along dam crest

(1) Remove trees on the downstream embankment to lessen the piping potential.

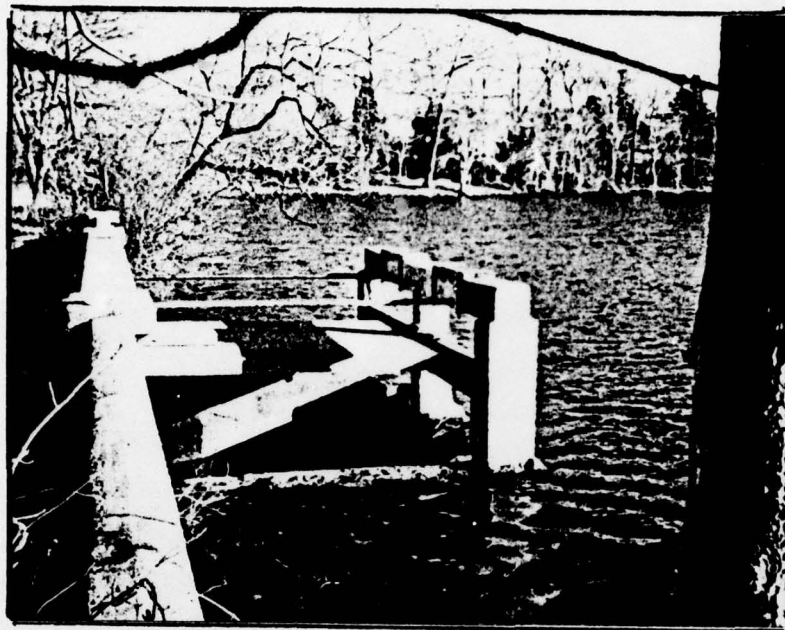
with a concrete access slab 1'-6" above the crest. This slab provides immediate access to the removable flash boards and theoretically could act as an anti-vortex device. However, as can be seen in Section 5, it somewhat limits the hydraulic capacity of the intake for surcharges greater than the 18-inch opening. The concrete on the intake is badly chipped and spalled and the lifting devices for removal of the stoplogs are completely destroyed. A type of chain-hoist attachment on the concrete railing and shackles was attached to the stoplogs but it is completely vandalized.

The spillway is a 3-sided concrete weir with 2 sets of timber flashboards, set about 6 inches below the top of concrete crest. Eighteen inches above the spillway crest, there is a maintenance slab which restricts the inflow for greater hydraulic heads. Based on the Recommended Guidelines for Safety Inspection of Dams, a spillway design flood (SDF) of 100-year frequency was selected by the inspection team. Inflow to the reservoir for the selected 100-year storm was computed utilizing precipitation data from Technical Publication 40 and NOAA Tech. Memo NWS - Hydro 35 by the HEC-1 program which gave a peak inflow of 3,553 cfs. Routing this storm through the reservoir reduced the peak discharge to 2,160 cfs. The spillway was a calculated capacity of 695 cfs and can thus accommodate only 32% of the design flood.

Spillway

(5) Repair the hoisting device for the stoplogs.

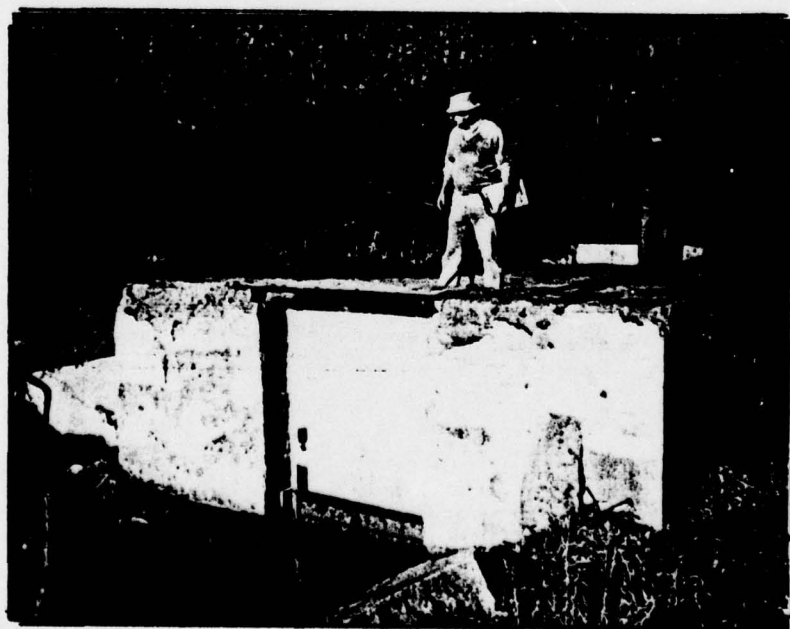
Inoperative sluiceway
